Formaldehyde Sampling

Manufacturer: Earthbound Rv
Serial Number: 113
Test Date 12/17/10

NTA Asset No. 01086

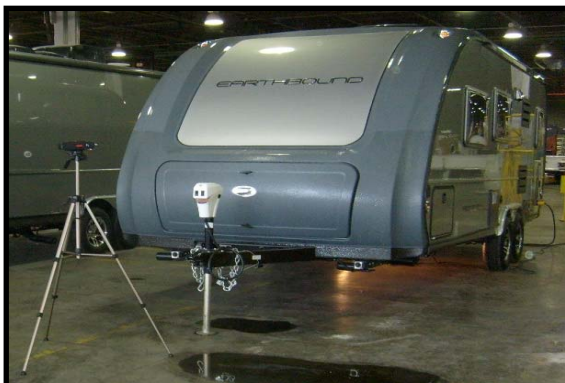
Location of Sampling: Outside of Rv

66.7	Degrees F
24.0	%
Less than 10	ppb

Outside of Rv

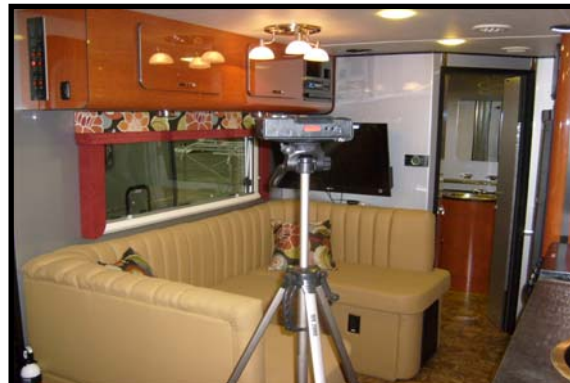
Location of Sampling: Inside of Rv in Living/Dining Area

Sampling Time	Sample Reading
1:09 pm	00 ppb
1:39 pm	20 ppb
30 minutes

Inside of Rv
